**Client:** Rugby School  
**Location:** School House, Rugby School, Rugby  
**Brief:** Renovate original staircase

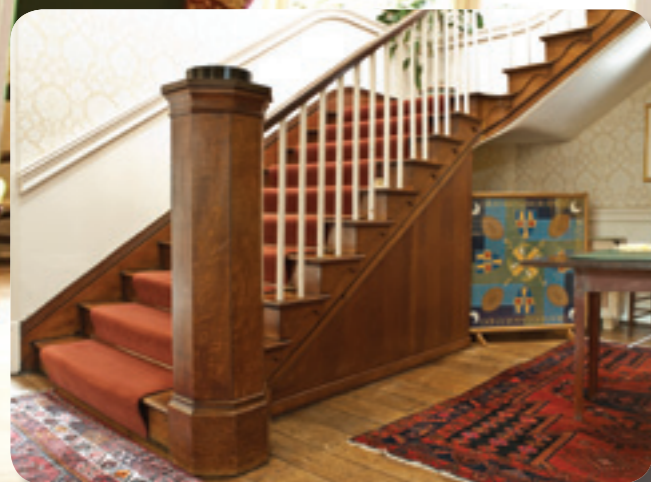
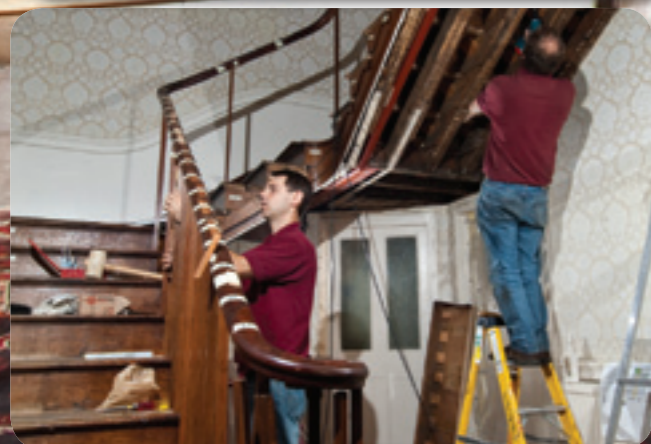
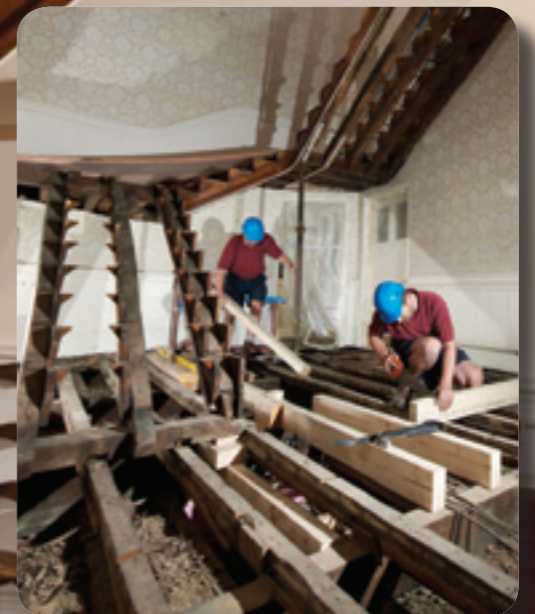
Upon closer inspection, it was clear to see that the staircase had sagged significantly over many years and was now considered to be a potential safety hazard. The amount of deflection in the structure was such that it was decided to extend the project and level the floor, which in places was up to 80mm from horizontal.

On lifting the floorboards, it was clear to see that the supporting structure was in a very poor condition, so new joists were fitted alongside the originals before the floor was repaired and re-laid. Once complete, our attention turned to the staircase.

Unfortunately, the rudimentary quality of existing timbers and metal supports, together with the multifarious nature of pieces used to 'repair' the stair, rendered this approach unfeasible because it would have transformed the project from one of restoration, to a thorough re-build.

Instead, additional steelwork was manufactured and installed to secure the structure in place. All the visible stair parts were repaired, with many requiring extensive restoration or rebuilding.

To complete the final phase of the project, original design features were restored including the removal of an inappropriate octagonal box section, which once supported a lamp and encapsulated the bottom tread and handrail volute. The handrail and balusters were then re-jointed to improve rigidity, prior to colouring and polishing, which successfully concluded the project and returned the staircase to use for many more years to come.

Material: English Oak with a Mahogany handrail  
Finish: Cleaned and revived with repairs in shellac
